Repair front bottom end. (10737/1)

Van Types	Caravan
Zone	Repair ()
Assembly Lines	Repair
Product Groups	T2 , T3

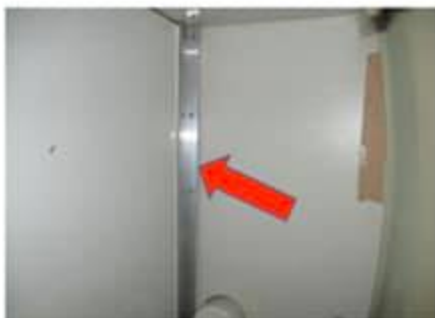
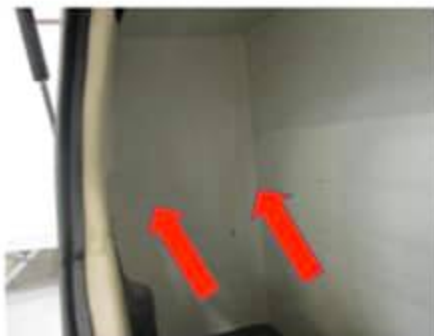
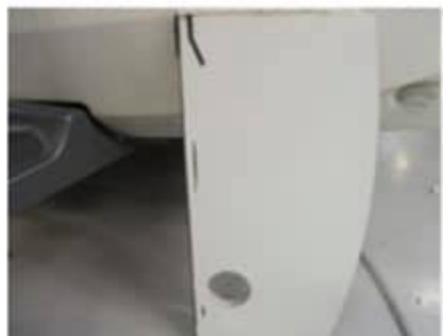
Step 1

With caravan parked and all 4 jack legs down. Access the gas locker box. If aluminium angle is visible remove fixing screws and remove angle. If angle is behind false panel carefully cut around sealant and remove flexible rubber then prise false panel away. On Door side it will require the BBQ pipe to be removed if fitted, then remove aluminium angle.

Clean and keep the panels / angle but discard the screws.

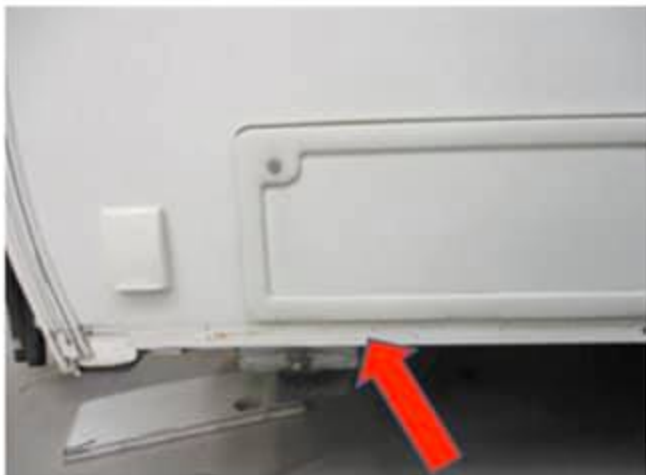
Step 2

Remove caps from front awning end caps and wheel spats. Remove Screws and carefully remove caps and spats - these will be held in place with tape behind the fixings. If "old" type spats used no fixings will be visible and the spat is adhered to clips around the wheel box - a scraper will be required to cut through the sealant. **Note Wheel spats may be left if rails or skirts can be removed carefully.**

Remove insert from front rub rails remove screws. Using a scraper carefully prise the rub rails off the jig side care to be taken not to delaminate the Sides.

If plastic skirts fitted lift the skirt of the carrier - it is stuck to the carrier in several positions so a knife / scraper will be required. Using a scraper carefully prise the rub rails off the jig side care to be taken not to delaminate the Sides.

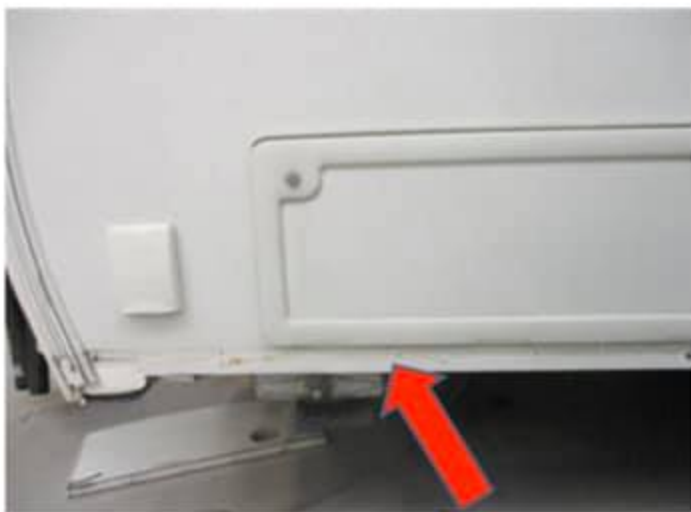
Step 3

Carefully remove all the sealant from the jig sides. Check for any damage caused by removal of skirts and repair if necessary. Remove all the floor / jig side M6 screws from the jig side - several may have snapped. Remove all from the front to the wheelarch.

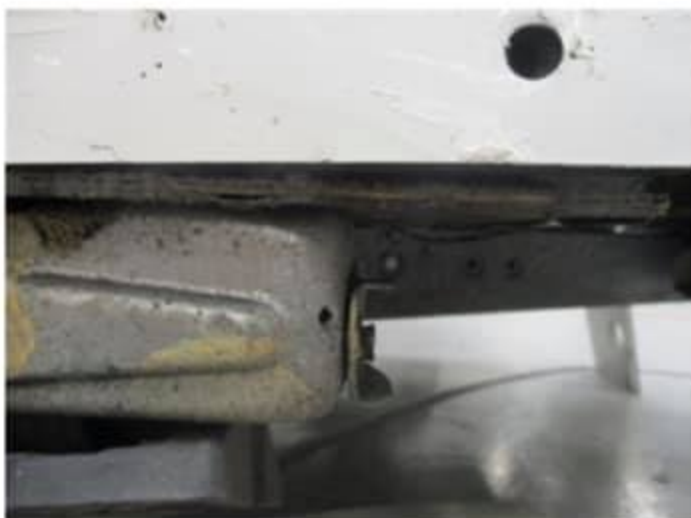
Step 4

Check bottom of jig side for any damaged or loose PU rails. If the rail is badly damaged scrape out damaged section and replace with a new section of rail using PUR adhesive. If the rail is just loose re glue in place with PUR adhesive. Note this adhesive is a "foaming" adhesive so care should be taken not to let the glue contaminate any other part of the van, also the rail will need holding (Tape) in place as the adhesive may push it out.

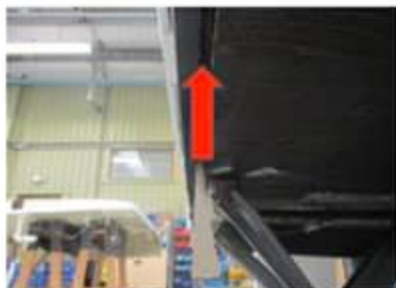
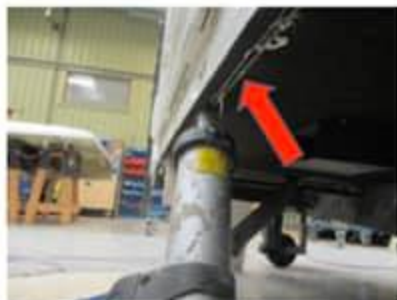
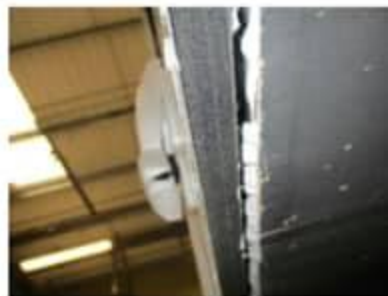
Step 5

Carefully wedge the floor away from the jig side and inject STR360 into the joint - care to be taken not to inject too much as this will show inside the van.

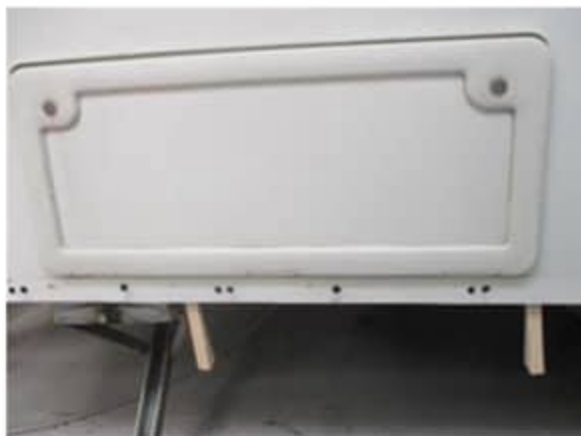
Step 6

Remove the wedges from the floor. Using either the vans jacks or a separate jack align the jig side with the bottom of the floor. Redrill holes for fixing using a 6mm drill bit at least 20mm away from existing holes - ensure new holes are not on the joints of any repaired PU rails. Drill extra holes between existing to "double up" the number of fixings. Using a 1/2" counter bore re-drill the holes so the screw head will sit flush with the GRP. Fix Jig Side to floor with M6 x 60 CSK screws.

Note - there may be metal/plastic plates under the van which position the jig side onto the floor these should contact the jig side if in the vicinity of the repair

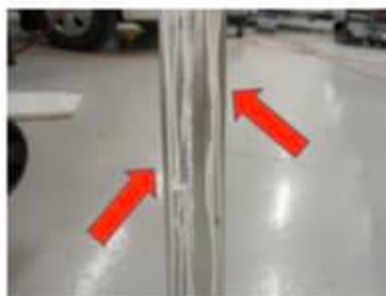
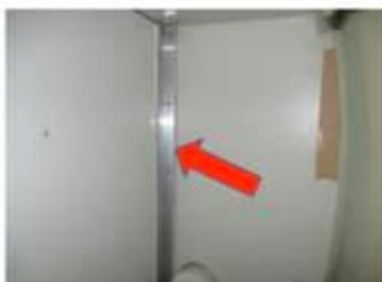
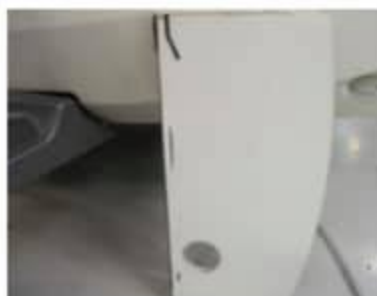
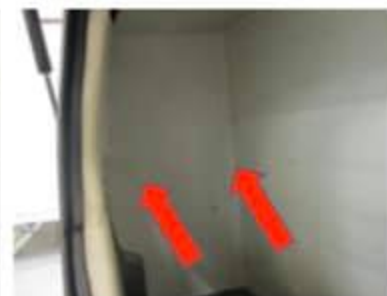
Step 8

Prime the aluminium angle and contact points on the jig side / front bottom end and the false panel (if fitted) with a clean lint free cloth dampened with Prep M and allow 5 mins to flash off.

Apply STR 360 to both faces of the angle, position onto the joint and screw in place with No 10 x 1" SS Pan Hd screws.

Apply STR 360 to the rear of the false panel (if fitted) and position into the corners and firmly push in place. Cut a length of roof finisher and stick it over the joint.

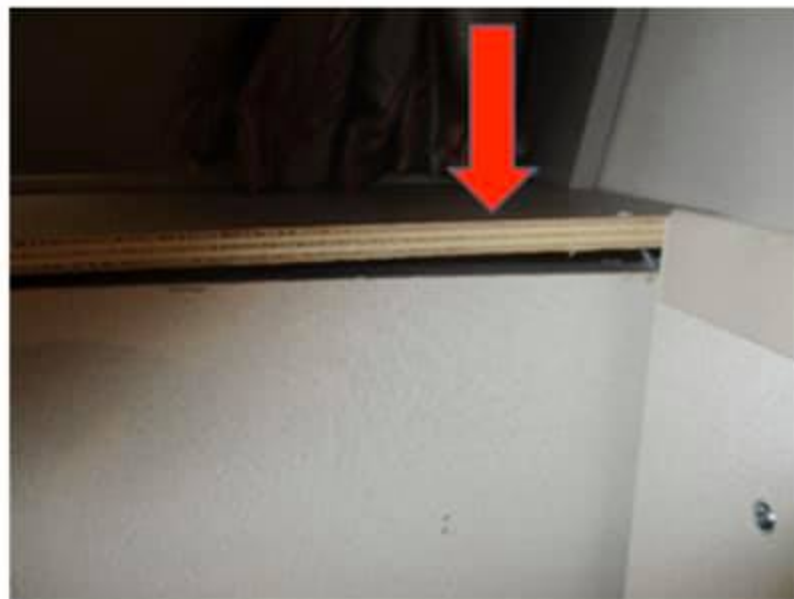
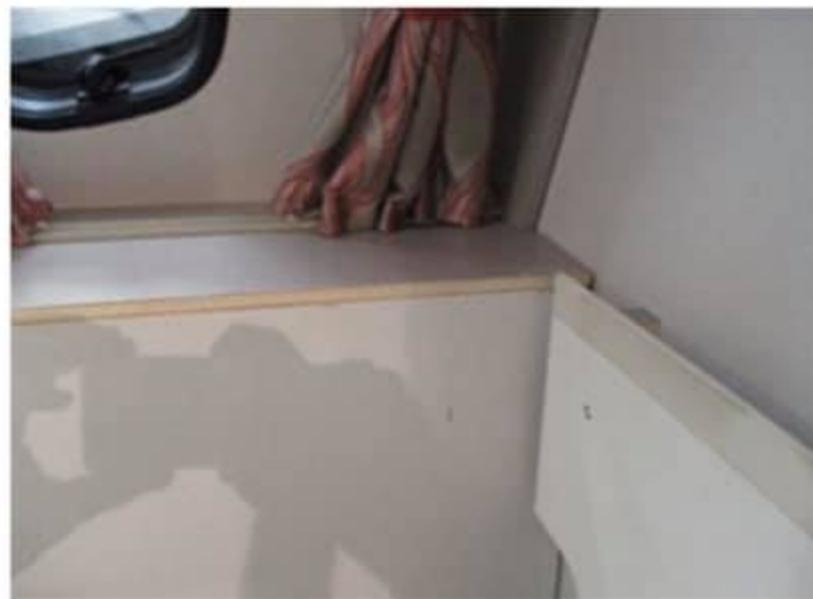
Step 9

Inside the van remove the front Binnacle and the L section from the front bottom shelf.

Check the shelf is correctly attached to the front bottom end add extra fixings to pull up as required.

Replace L section and Binnacle.

Check the remainder of the screws into the front bottom end under the van. If any of the screws are missing or loose check the rail for damage and if no damage fit new screws adjacent to the current screw. If the rail is damaged replace the rail as per the side rails and refit the screws.
